Date: August 11, 2015
To: Rogelio Lozada WP – Commissioning Mgr.
Luis Ramirez WP - Sr. Process Engineer
From: Javier Rios UOP Tech Service Specialist
CC: Distribution
Customer: EP PetroEcuador – Esmeraldas, Ecuador
Subject: **UOP-EPP-FCC PROC-024- Hot Spot recommendations for fixes and proposed path forward for 8-5-2015 inspection**

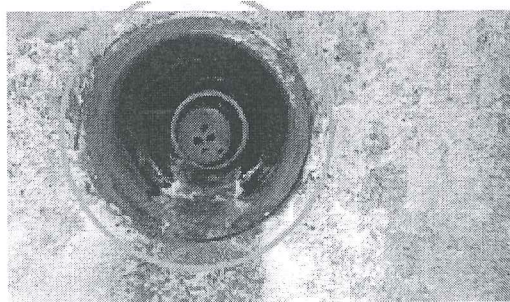
Regarding the torch oil nozzle with ring cover – this is a level 3 deviation and it is optional to install. The ring coverage is not as effective for protection against erosion. The recommendation was to ensure to give further protection to the system.

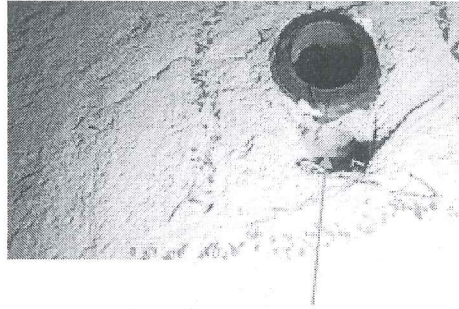
Refractory repair – Level 4

West end

East end

Repair for refractory after checking with specialist the plate coverage will not cover the section and be effective towards removal. Due to that reason we removed on new units the ring coverage for a few items. The repair must be done as per recommended UOP specification 3-22-7.

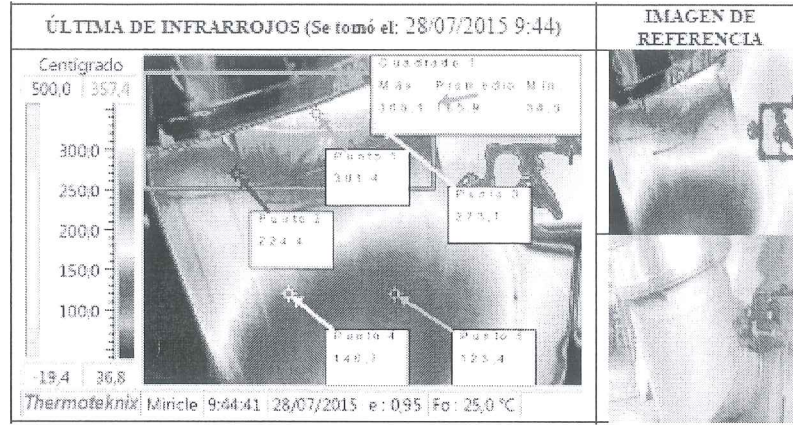
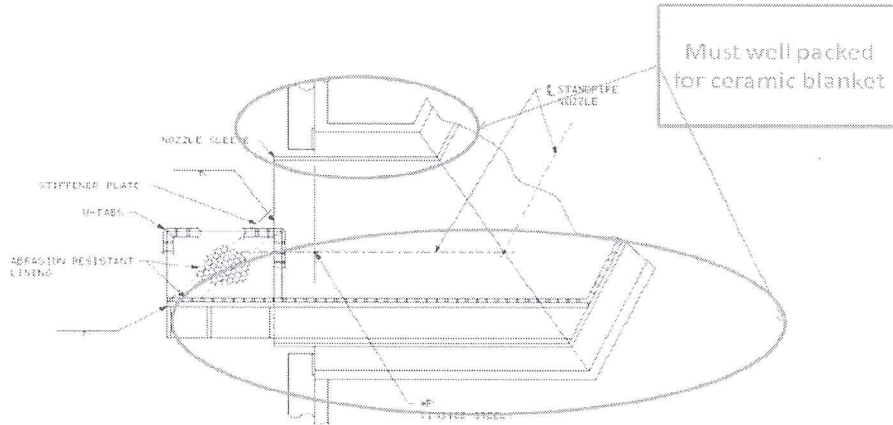
Spent catalyst Stand pipe – Level 5

The hot spot was located and inspected for refractory.

Prior to ceramic packing

After careful review UOP understands that the potential main root cause for the stand pipe is that the ceramic packing was not incorrectly placed. This created a hot spot in the upper part due to air concentration and not able to isolate the system. The problem most likely might be internal due to the already added packing to the system outside:

Unfortunately to fix this item the refractory and the ring must be removed to ensure that repacking the ceramic blanket to ensure the section is properly. Please note that the main reason is due to the internal ceramic that must have had cover the section. If the section of the ring is not removed then the bended section is hard to remove the packing and ensure it will work correctly.

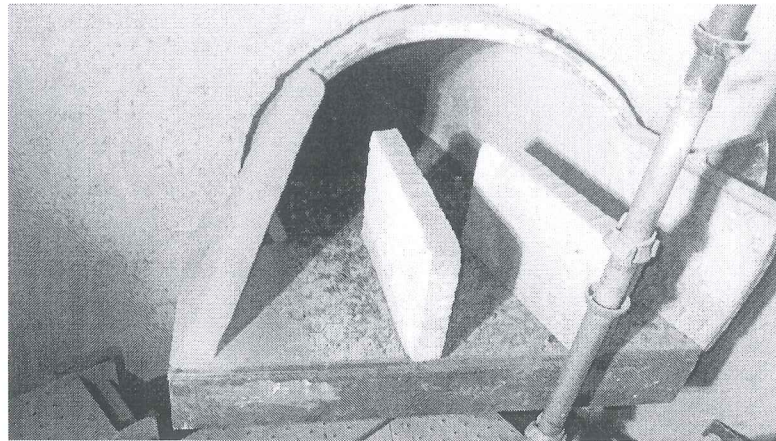
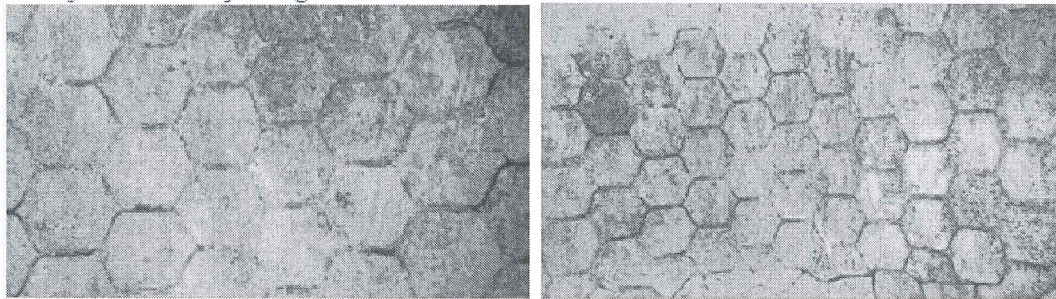
Refractory lining installed in the shop (above the hot spot)

Refractory on the hot spot section

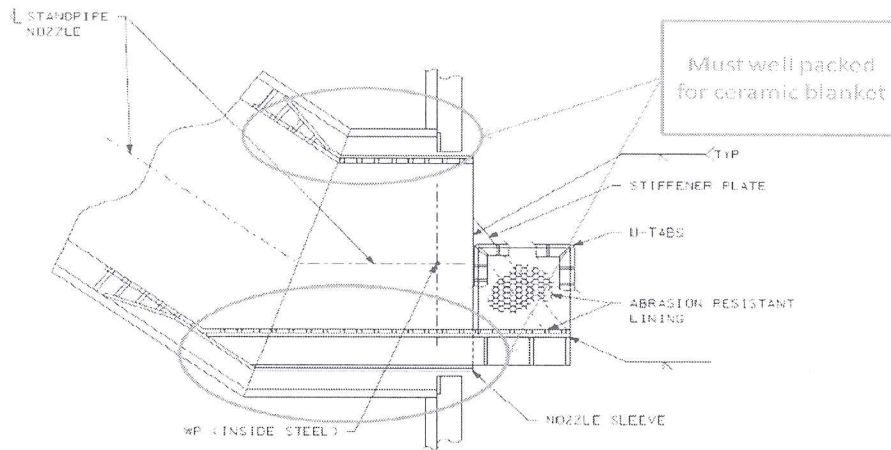
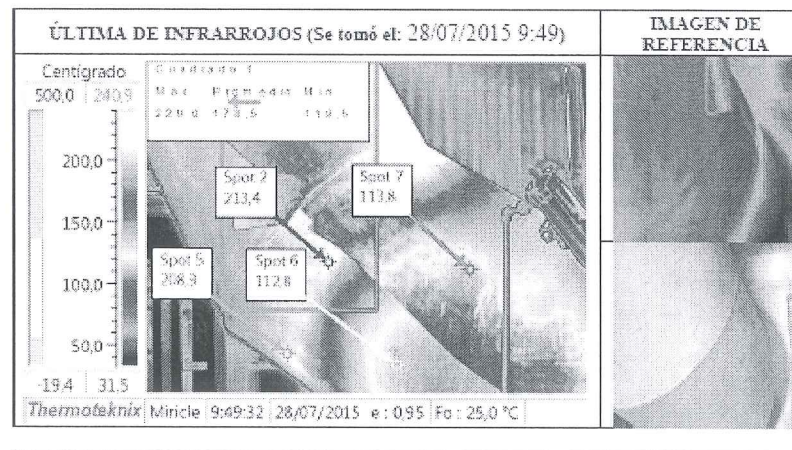
5 Re-circulation Stand pipe

The hot spot was located and inspected for refractory.

Prior to ceramic packing

After careful review UOP understands that the potential main root cause for the stand pipe is that the ceramic packing was not incorrectly placed. This created a hot spot in the upper part due to air concentration and not able to isolate the system. The problem most likely might be internal due to the already added packing to the system outside.

Unfortunately to fix this item the refractory and the ring must be removed to ensure that repacking the ceramic blanket to ensure the section is properly. Please note that the main reason is due to the internal ceramic that must have had cover the section. If the section of the ring is not removed then the bended section is hard to remove the packing and ensure it will work correctly.

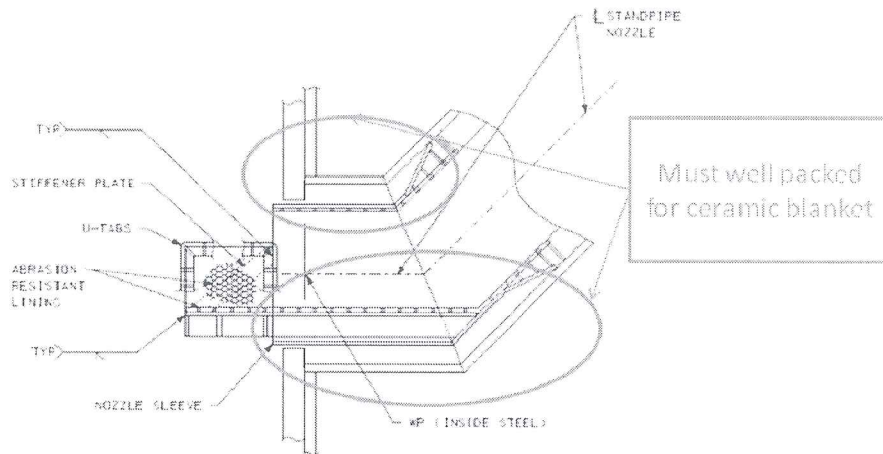
Catalyst Cooler Stand pipe – Level 4

This item is recommended to be checked since we don't have an IR and as per findings on the other stand pipes it seems that they were not properly installed. This can be confirmed on the findings for the other stand pipes packing for the upper section.
